ANNUAL REPORT FOR 2010

**UT Town Creek Mitigation Sites
Rowan County
TIP No. I-2511CA**

Prepared By:
Natural Environment Unit & Roadside Environmental Unit
North Carolina Department of Transportation
December 2010

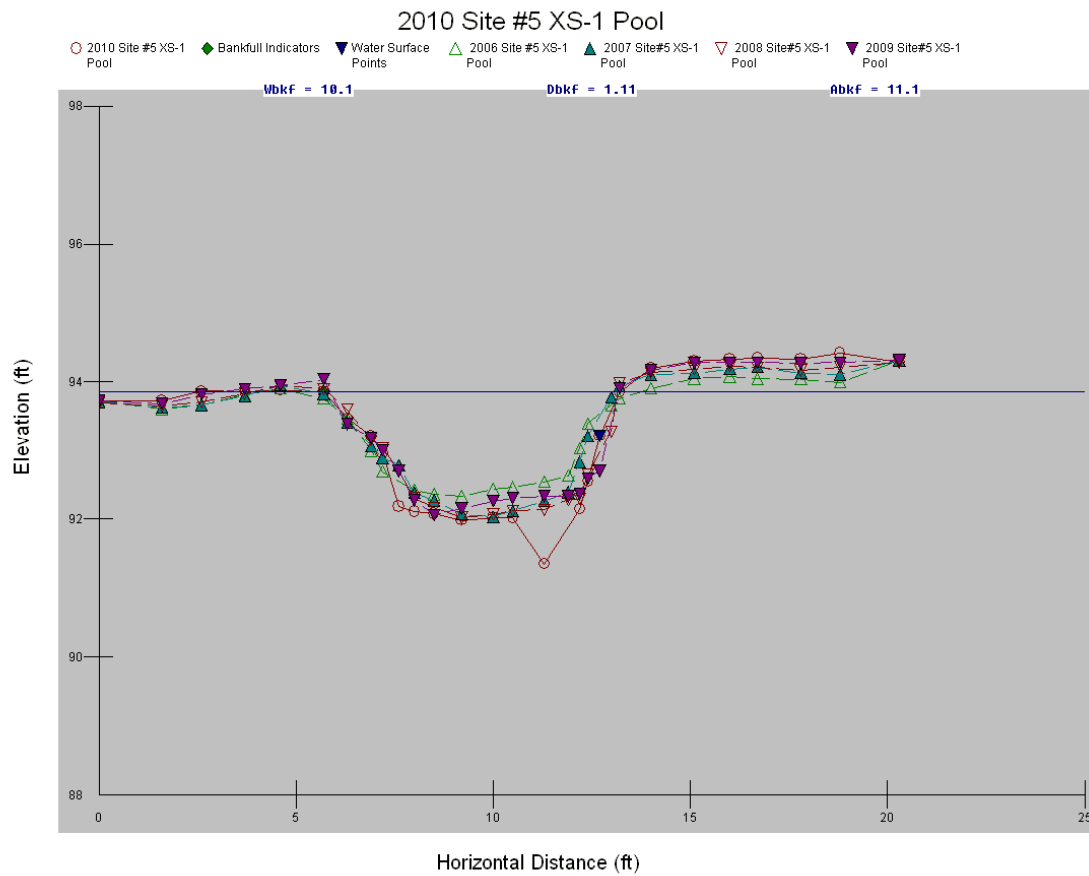
Site #5: Cross-Section #1 (Pool) Abbreviated Morphological Summary*					
	2006	2007	2008	2009	2010
Bankfull Cross Sectional Area (ft ²)	9.49	10.67	11.18	11.87	11.11
Maximum Bankfull Depth (ft)	1.58	1.91	1.92	1.98	2.51
Bankfull Mean Depth (ft)	0.68	0.82	0.85	0.87	1.11
Bankfull Width (ft)	14.0	13.05	13.19	13.6	10.05

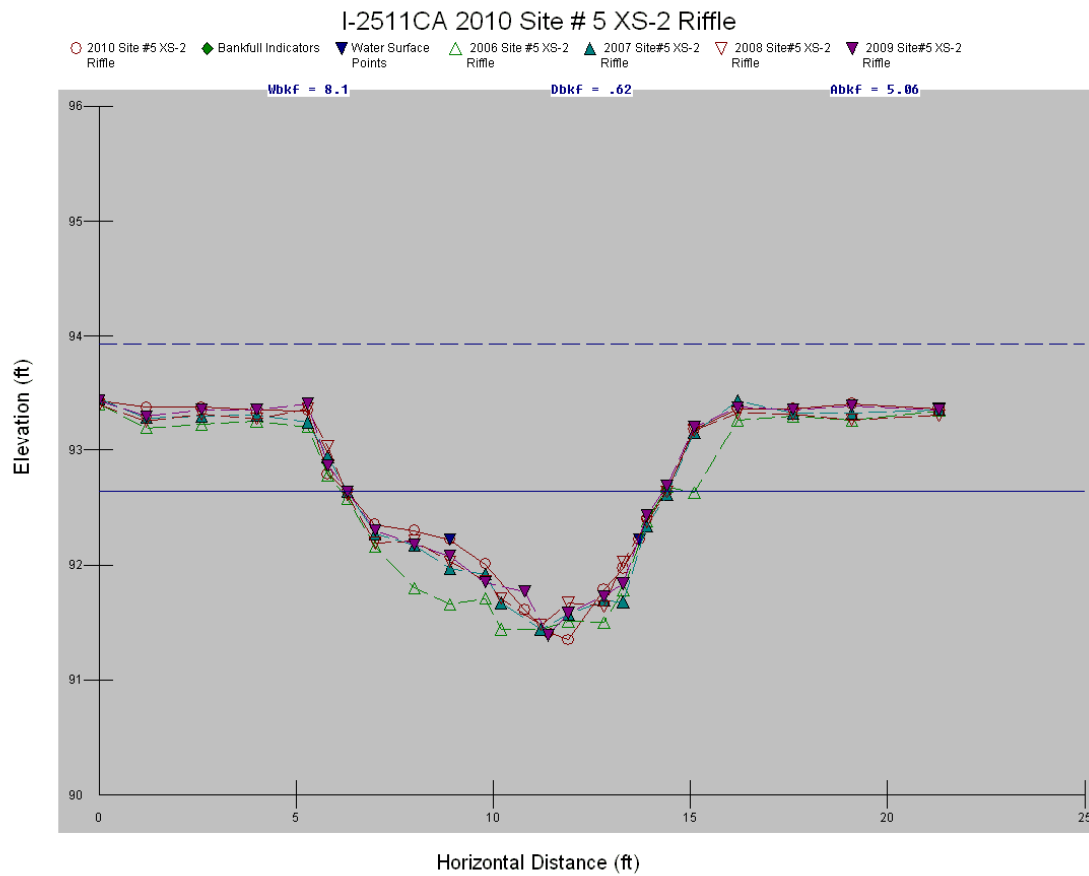
Site #5: Cross-Section #2 (Riffle) Abbreviated Morphological Summary					
	2006	2007	2008	2009	2010
Bankfull Cross Sectional Area (ft ²)	7.24	5.51	5.46	5.69	5.06
Maximum Bankfull Depth (ft)	1.24	1.17	1.16	1.3	1.29
Width of the Floodprone Area (ft)	34.6	21.3	21.3	21.3	20.17
Bankfull Mean Depth (ft)	0.79	0.69	0.67	0.69	0.62
Width/Depth Ratio	11.57	11.65	12.15	11.9	13.06
Entrenchment Ratio	3.79	2.65	2.62	2.59	2.49
Bankfull Width (ft)	9.14	8.04	8.14	8.21	8.10

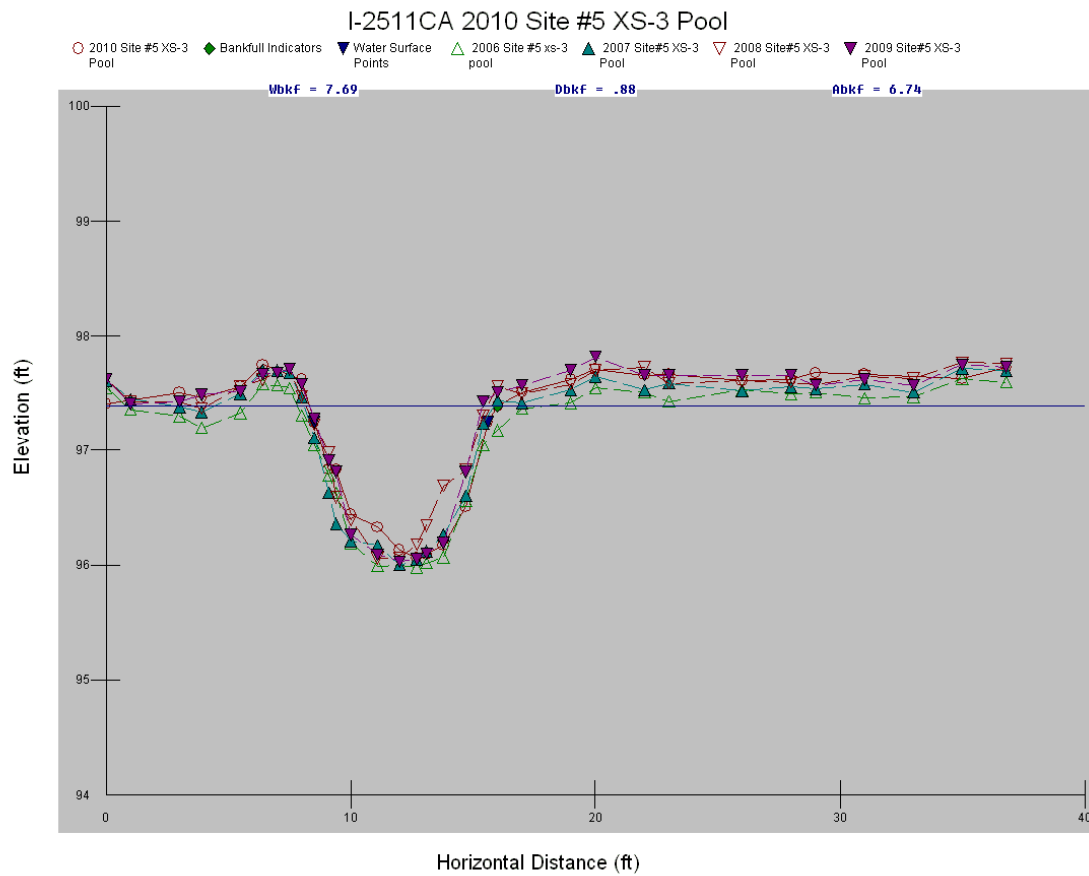
Site #5: Cross-Section #3 (Pool) Abbreviated Morphological Summary*					
	2006	2007	2008	2009	2010
Bankfull Cross Sectional Area (ft ²)	7.83	7.68	7.3	7.87	6.74
Maximum Bankfull Depth (ft)	1.39	1.42	1.44	1.48	1.33
Bankfull Mean Depth (ft)	0.86	0.72	0.61	0.64	0.88
Bankfull Width (ft)	9.13	10.71	11.94	12.33	7.69

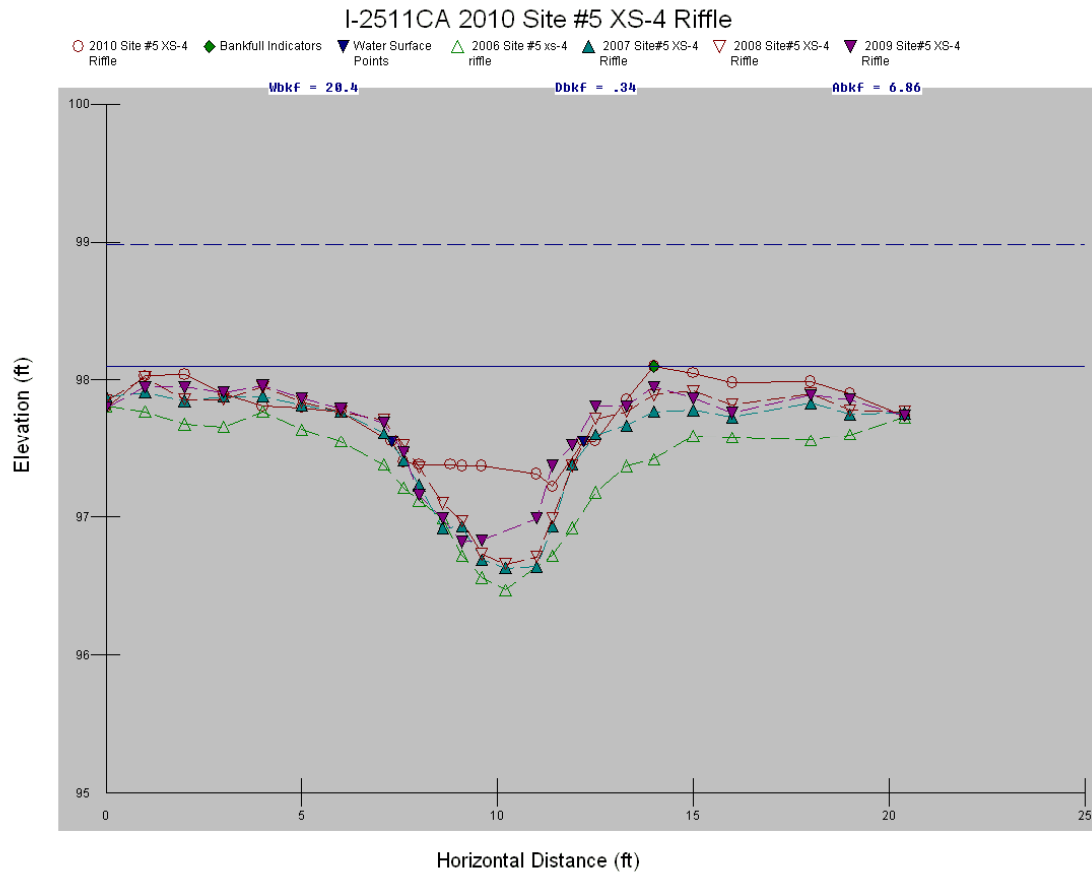
Site #5: Cross-Section #4 (Riffle) Abbreviated Morphological Summary					
	2006	2007	2008	2009	2010
Bankfull Cross Sectional Area (ft ²)	4.65	4.48	5.06	5.61	6.86
Maximum Bankfull Depth (ft)	1.12	1.15	1.26	1.13	0.88
Width of the Floodprone Area (ft)	20.4	20.4	20.4	20.4	20.4
Bankfull Mean Depth (ft)	0.50	0.35	0.3	0.29	0.34
Width/Depth Ratio	19.27	37.09	25.89	65.83	60.00
Entrenchment Ratio	2.16	1.57	1.79	1.07	1.00
Bankfull Width (ft)	9.44	12.98	11.39	19.09	20.04

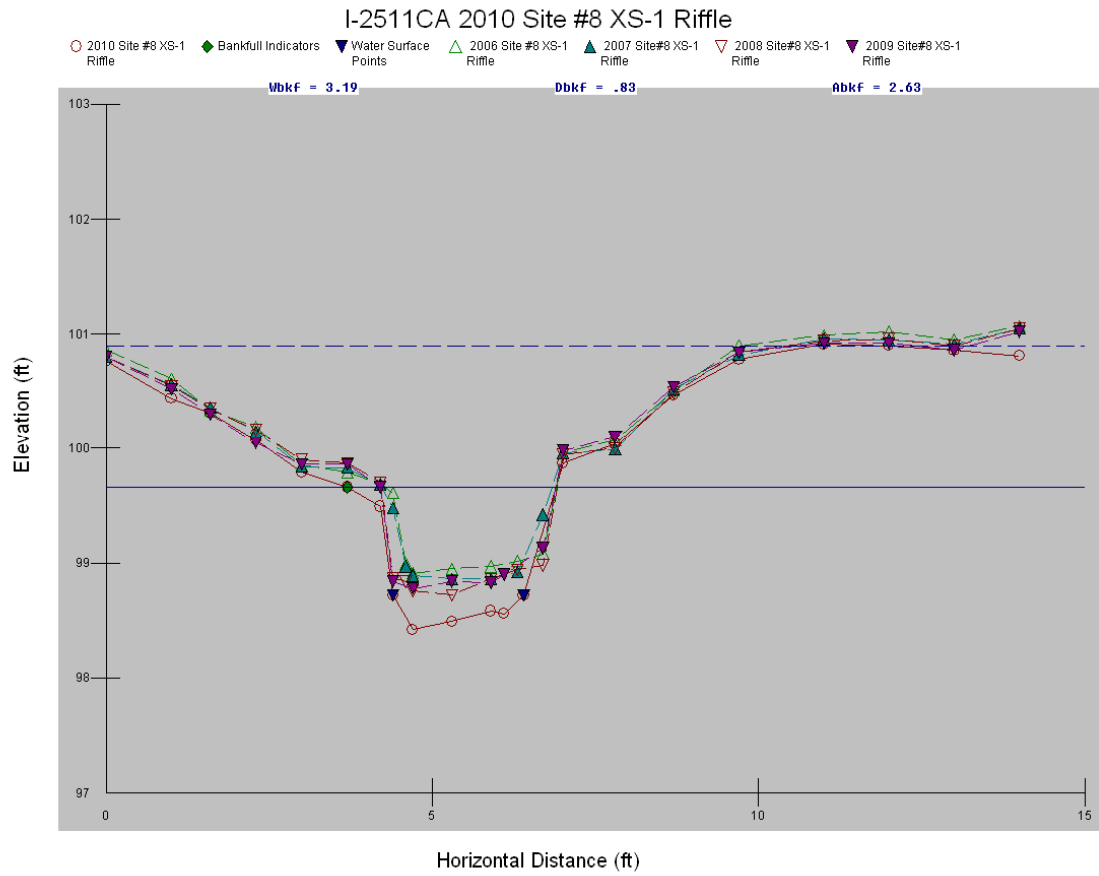
Site #8: Cross-Section #1 (Riffle) Abbreviated Morphological Summary					
	2006	2007	2008	2009	2010
Bankfull Cross Sectional Area (ft ²)	2.62	2.67	2.94	2.53	2.63
Maximum Bankfull Depth (ft)	1.05	1.10	1.22	1.08	1.24
Width of the Floodprone Area (ft)	13.02	14	14	13.5	12.9
Bankfull Mean Depth (ft)	0.62	0.62	0.72	0.78	0.83
Width/Depth Ratio	6.82	6.89	5.71	4.18	3.84
Entrenchment Ratio	3.08	3.28	3.41	4.14	4.04
Bankfull Width (ft)	4.23	4.27	4.11	3.26	3.19

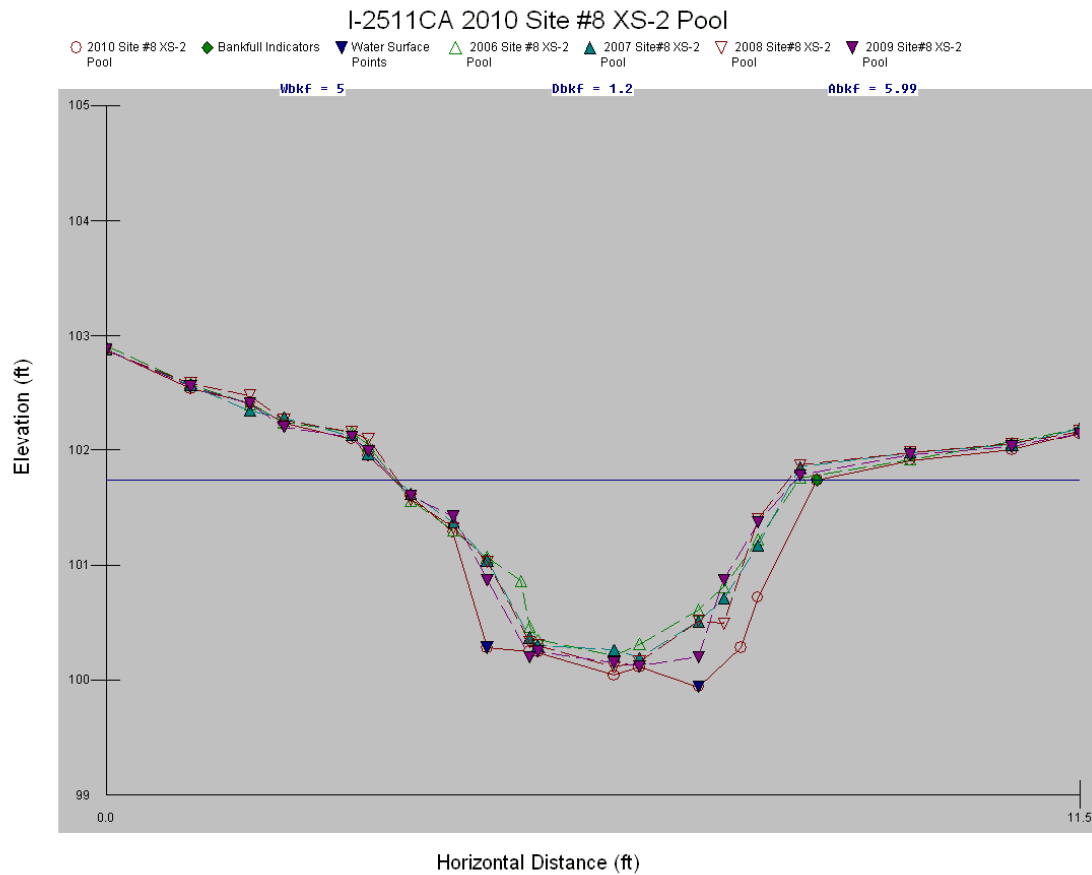
Site #8: Cross-Section #2 (Pool) Abbreviated Morphological Summary*					
	2006	2007	2008	2009	2010
Bankfull Cross Sectional Area (ft ²)	4.42	5.05	5.28	4.98	5.99
Maximum Bankfull Depth (ft)	1.55	1.66	1.76	1.66	1.80
Bankfull Mean Depth (ft)	0.92	1.03	1.08	1.03	1.20
Bankfull Width (ft)	4.81	4.93	4.88	4.83	4.17

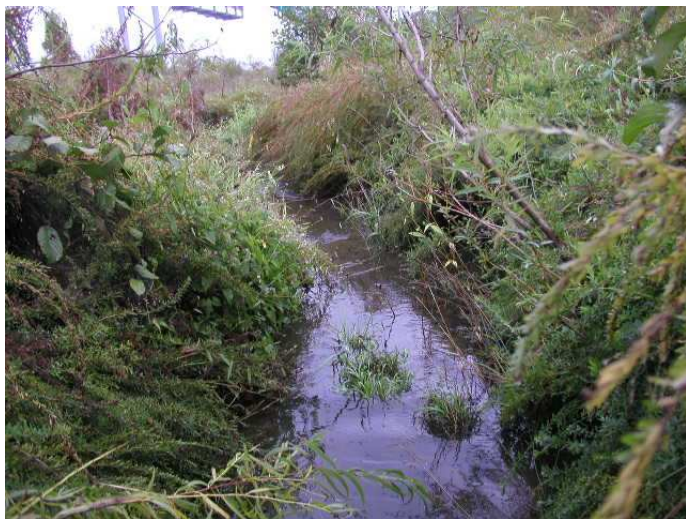
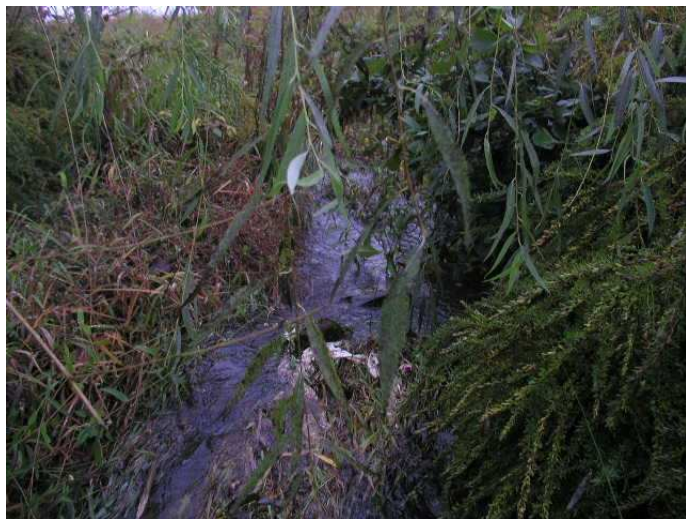
Photo Point #7 (Downstream)

The stream was visually inspected along the length of the channel. The stream relocation portion south of US 52 on the inlet side of the pipe (photo point #7) is experiencing some areas of localized bank scouring but appears to be stable. On the outlet end of the pipe north of US 52, the channel pattern up and down stream at photo point #6 has changed since the stream channel was constructed. The channel within this section has straightened and the sinuosity has decreased. It appears that there was too much sinuosity designed into this urban stream setting but the channel has now stabilized. A small beaver dam located just downstream of cross section #3 was removed. DWQ reported in their March 10, 2009 comments that there were areas where the banks are sloughing into the stream around photo points #1 to #3. There appears to be a new bankfull bench developing in some of these areas and they appear to be stable.
